MANAGEMENT OF PERSISTENT STANDING AT THE CARDIFF CITY STADIUM

UPDATE REPORT FIVE

**Version 1.0
Report
16 November 2015**

Prepared By
Dr Steve Frosdick
IWI Associates Ltd
Locks Heath, Southampton SO31 6DG

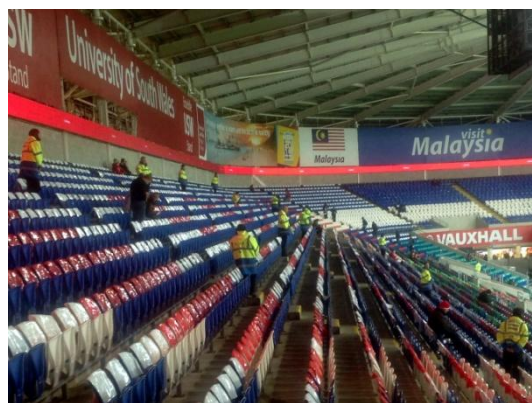
- 2.2.1. The stewarding deployments were monitored from before the stadium opened to the public. Direct observations were then kept from the gantry behind the stand from 40 minutes before until 20 minutes after kick-off.
- 2.2.2. The stewards were observed to be deployed in precise accordance with the plan. There were the specified numbers of stewards at the vomitories, in the gangways, on the field gates and in the replacement pool.

The stewards were deployed in precise accordance with the plan

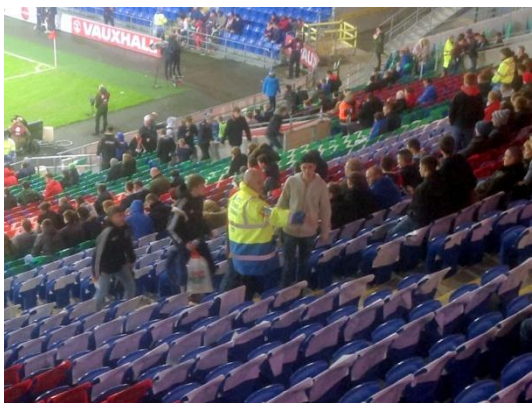
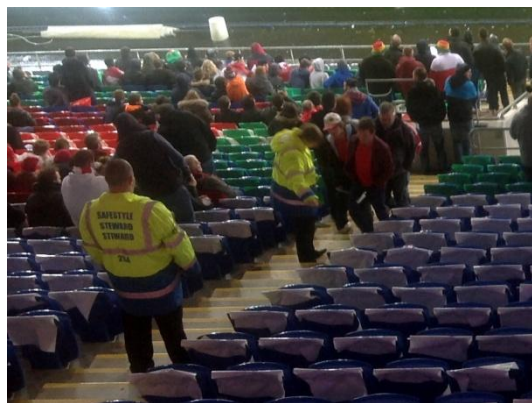
- 2.2.3. Spectator tickets showed block, row and seat numbers. Crowd access to the stand was observed to be gradual and slow. Spectators were seen having their tickets checked and their seats pointed out by stewards. Stewards at row AA were seen checking tickets so that people did not migrate further backwards than their tickets allowed.

Stewards were checking tickets and politely pointing out the location of the spectators seats

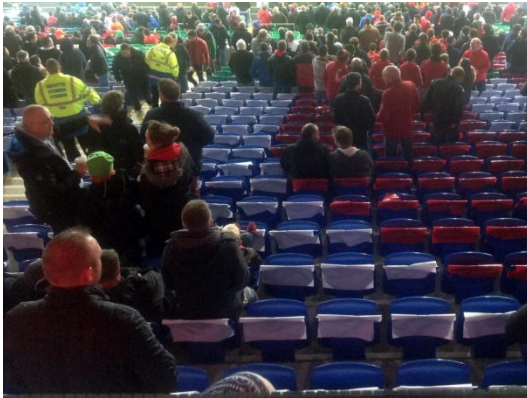
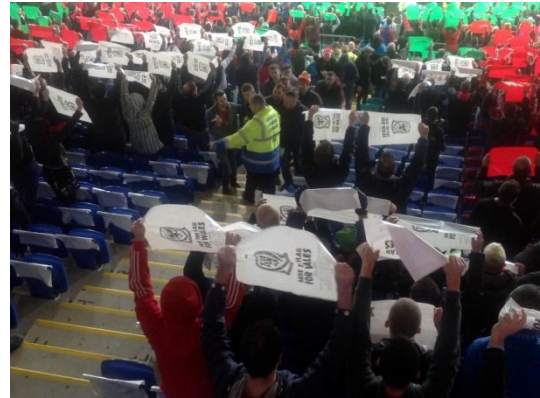
At six minutes and then three minutes to kick-off, it was clear there had been no migration backwards

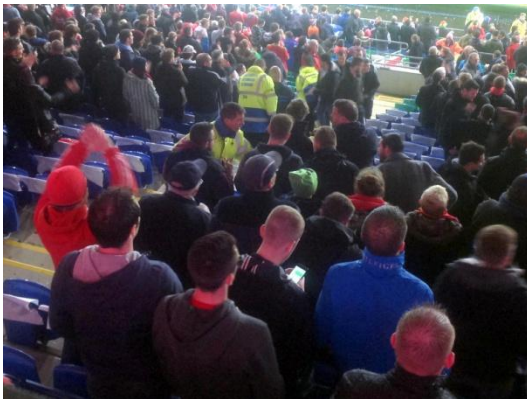
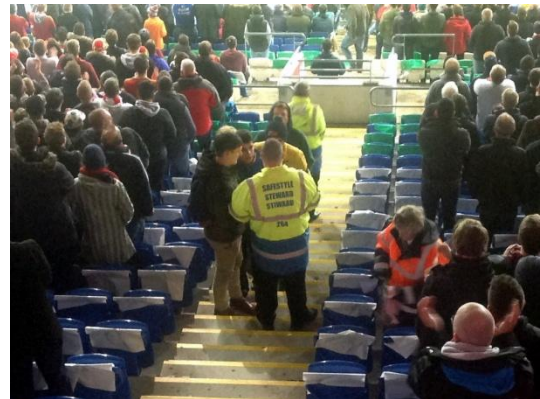
Stewards were active in preventing lateral migration into the empty seats

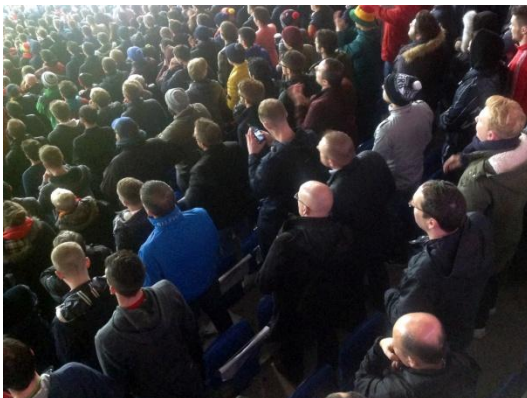
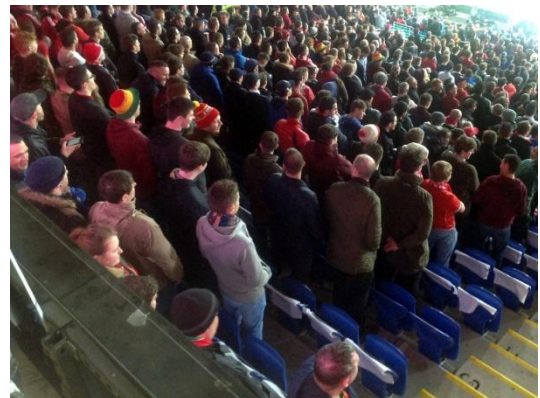
At five minutes after kick-off, there is clearly no overcrowding whatsoever in the stand

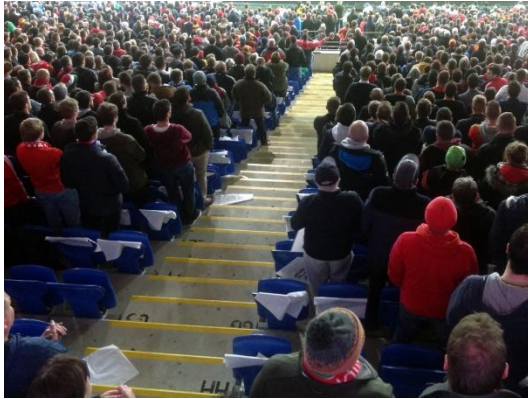
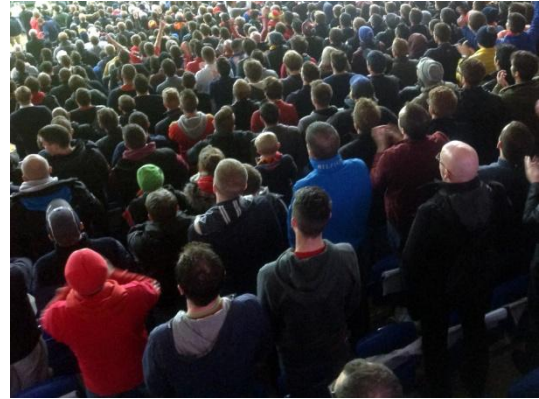
- 2.2.6. The wisdom of the plan of keeping the two empty seats at the end of each row clear became apparent when the match was approaching its conclusion and the gangway stewards were withdrawn to protect the pitch perimeter. There was some minor lateral migration into the empty seats, however the gangways remained clear until the end of the match. There was also no evidence of radial migration backwards and there was no overcrowding to be seen.

The gangways remained clear and there was no overcrowding even after the stewards withdrew

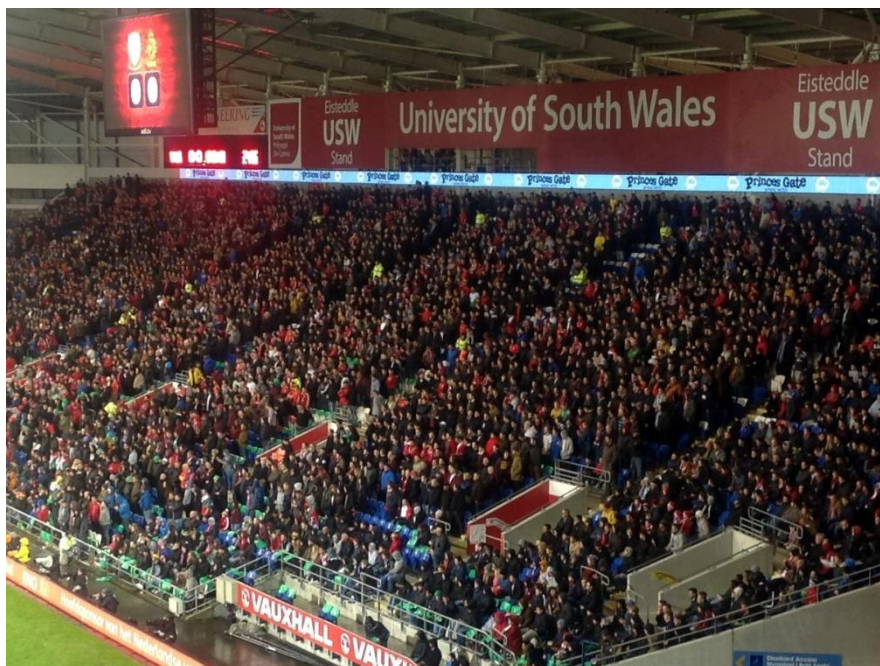
- 2.3.1. For this match, the customer service and security risks in the Canton Stand were low. The safety risks associated with the physical infrastructure were also low. However there were concerns about safety risks arising from radial and lateral spectator migration by persistently standing fans. These risks were very well managed through a planned reduction in capacity, planned stewarding deployments, very active and effective stewarding and a high level of spectator co-operation.

*The persistent standing in the Canton Stand was very well managed.
Gangways were kept clear and overcrowding was prevented throughout the match*

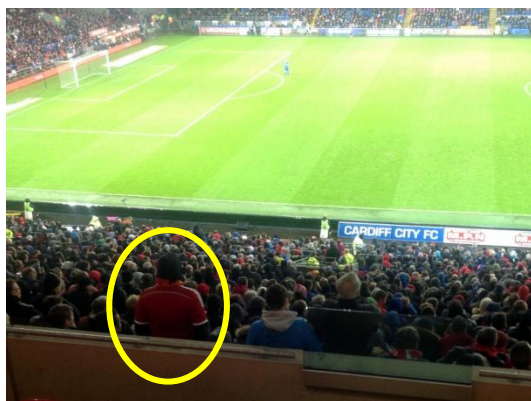
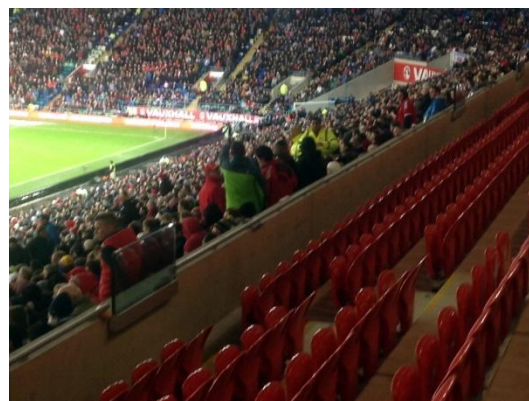
- 3.2.3. At 2022 hours, two stewards were seen to deploy up the gangway and to ask the five persons to sit down. Four of them did so. One man in a red coat was seen arguing with the stewards, refusing to sit down and then to begin filming the stewards on his mobile phone. This was wilful non-compliance with the stewards' reasonable request.

- 3.2.4. At half-time, the man was invited to come down onto the concourse for a discussion about his conduct. He declined to do so. Shortly afterwards, the man was rightly ejected by two members of the stewarding response team.

The one person who persistently stood and refused to sit when asked was ejected at half-time

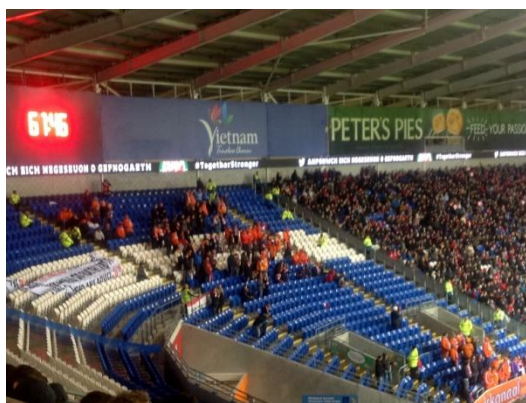
- 4.1.1. The attendance in the away section was expected to be 190 persons but appeared to be lower. Some were seated and some remained standing, however the very low crowd density and the fans' demeanour meant that there were no safety, security or service risks apparent.

The crowd density in the away section was very low and no risks were apparent

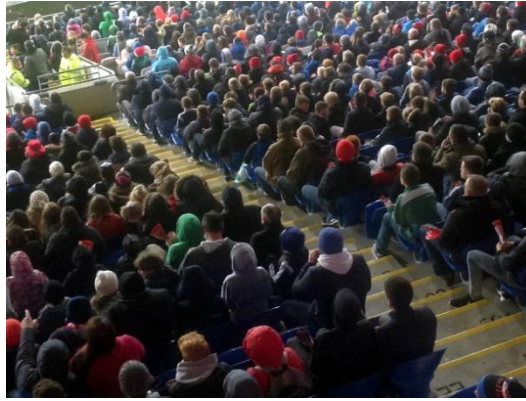
- 4.2.1. Direct observations were kept from the 46th until the 52nd minute. After the second half kicked off, the crowd drafted back into the bowl and retook their seats. By the 52nd minute, everyone appeared to have returned. All gangways were seen to be clear and no persistent standing was observed.

Gangways were clear and there was no persistent standing in the Grange Stand Family Section

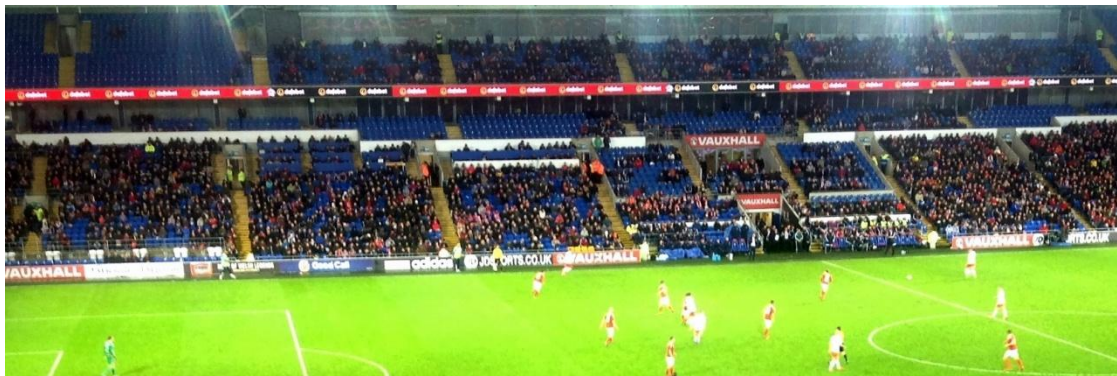
- 4.3.1. The Grandstand was monitored from the observation positions from time to time over the course of the match. All gangways were seen to be clear and no persistent standing was observed.

Gangways were clear and there was no persistent standing in the Grandstand
